RE: SERVICE NOTICE
TOMY MX-Series High Speed Refrigerated Micro Centrifuges
TOMY MicroTwin Refrigerated Tabletop Centrifuge

This letter is to inform you that the manufacturer TOMY KOGYO CO., LTD. (“TOMY”) is voluntarily conducting service work through TOMY DIGITAL BIOLOGY CO., LTD., for the following specific models of the TOMY MX-Series High Speed Refrigerated Micro Centrifuge and TOMY MicroTwin Refrigerated Tabletop Micro Centrifuge:

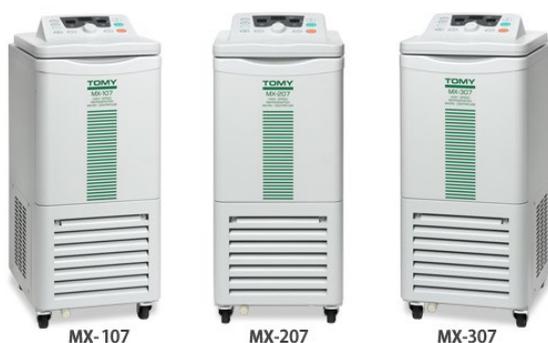
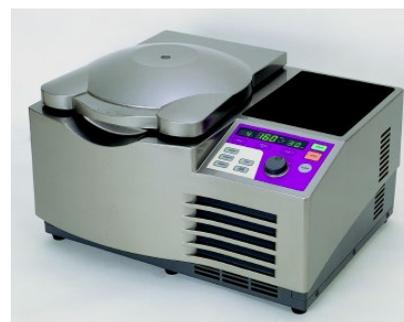
The voluntary service offering has been initiated due to a report that the chamber lids of certain TOMY MX-Series High Speed Refrigerated Micro Centrifuges and TOMY MicroTwin Refrigerated Tabletop Micro Centrifuge may accidentally open while in use if the rotor rack is not installed into the rotor properly.

Proper installation of the rotor rack is essential to maintaining the balance in the centrifuge while it is spinning. Failure to install the rotor rack properly may cause the rotor rack to come off the rotor, and the force created by the rotor rack coming off the rotor while the centrifuge is in use may result in the locked centrifuge lid bursting open. This may create a dangerous situation for the person operating the centrifuge.

To improve safety, TOMY has decided to send service personnel to users' facilities to update the lid lock unit of the above-listed centrifuge models. Further, for Centrifuge Model **MX-300 120V Nos. from 36080001 to 39080020** and **MX-301 120V Nos. from 39325001 to 40325010**, TOMY will also install an additional safety adapter in the lid that covers the rotor.
